A Red Light Running (RLR) Photo Enforcement System was installed at the intersection of IL Rte. 12/20/45 (Mannheim) at St. Charles Road on July 11, 2008 (southbound/eastbound), after finding limited success with other attempted measures to promote safer driving and improve compliance with traffic laws. As a condition of use, both Illinois law and the Illinois Department of Transportation require periodic statistical analyses/evaluations be conducted.

IL Rte. 12/20/45 (Mannheim) at St. Charles Road **Bellwood, IL**

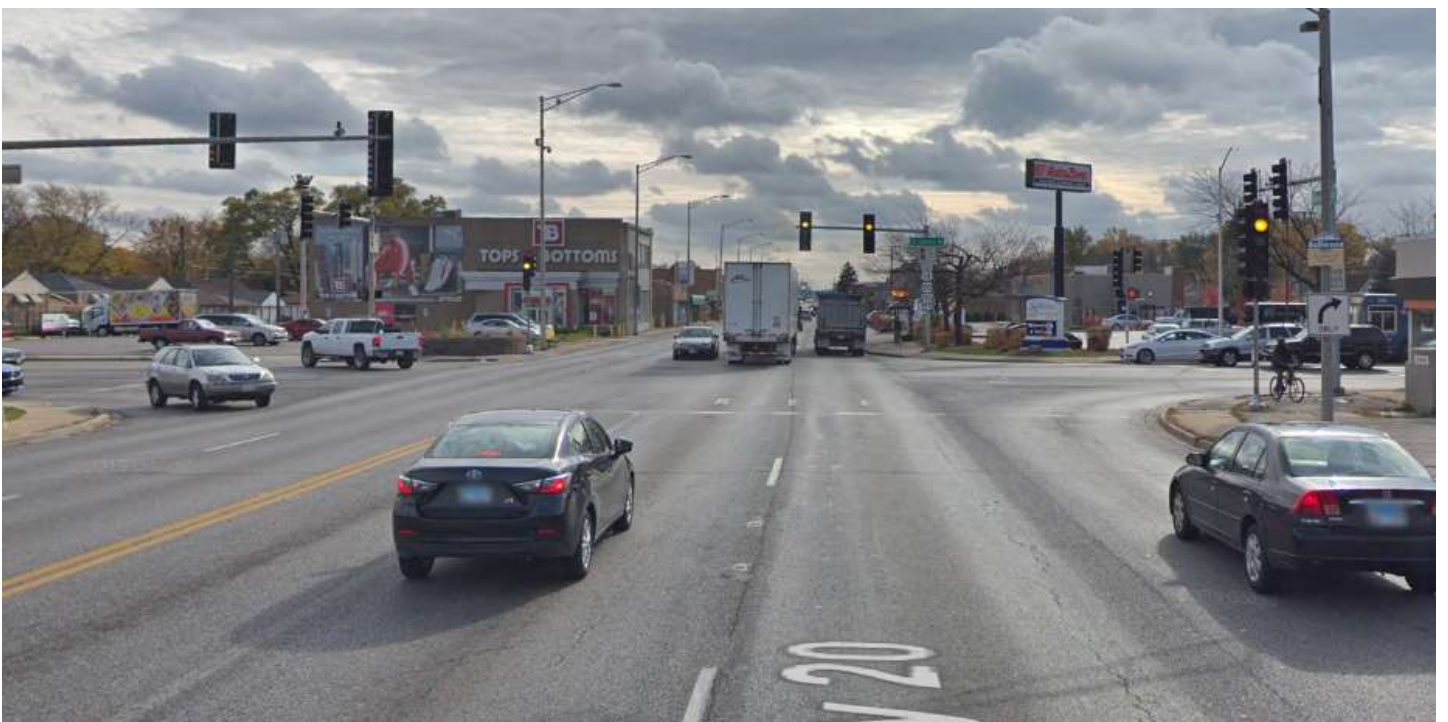
IL Rte. 12/20/45 (Mannheim) at St. Charles Road, Southbound Approach

- RLR Photo Enforcement System monitors violations occurring on the southbound and eastbound approaches of the intersection
- RLR Photo Enforcement System installed: July 11, 2008
- Traffic signal timing strictly adheres to the guidelines for timing of clearances established by the Illinois Department of Transportation (IDOT), in accordance with the MUTCD standards. Neither the Vendor nor the Village has access to or influence over the establishment of signal timings. Both entities understand that tampering with these timings would be a safety violation with significant consequences.
